Name Of Dam: WHEATLANDS
Location: FREDERICK COUNTY, VIRGINIA
Inventory Number: VA 06913

PHASE I INSPECTION REPORT NATIONAL DAM SAFETY PROGRAM.

Wheatlands Dam. (Inventory Number VA-06913),
Potomac River Basin. Frederick County,
Virginia. Phase I Inspection Report.

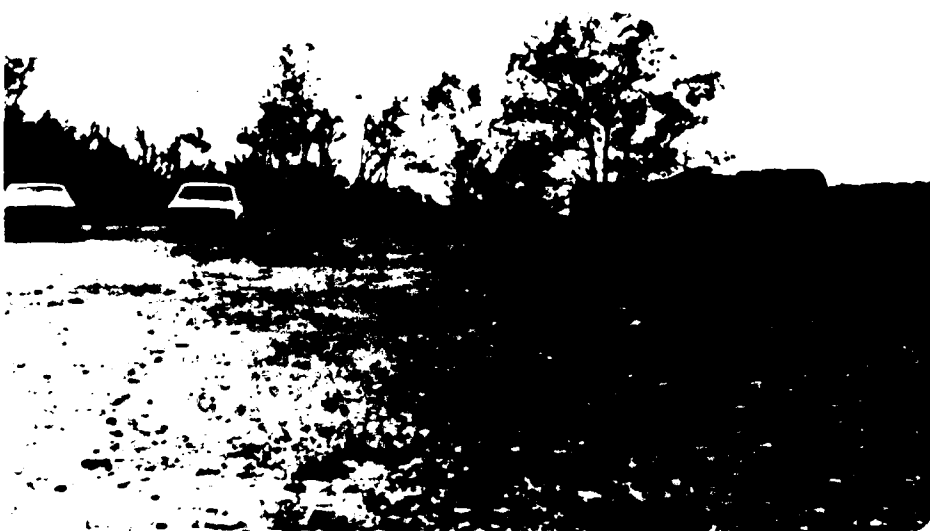
3.1.4 Emergency Spillway: The control section is in natural ground with a few rock outcrops. A severed portion of the damaged 72-inch CMP drop inlet riser (principal spillway) presently sits in the control section. (See Photos. No. 9 and 10). The approach channel is grassed and in good condition. The discharge channel is steep and heavily wooded.

PHOTO #9 EMERGENCY SPILLWAY

PHOTO #10 EMERGENCY SPILLWAY
